Tightening the gap at the bottom of the box

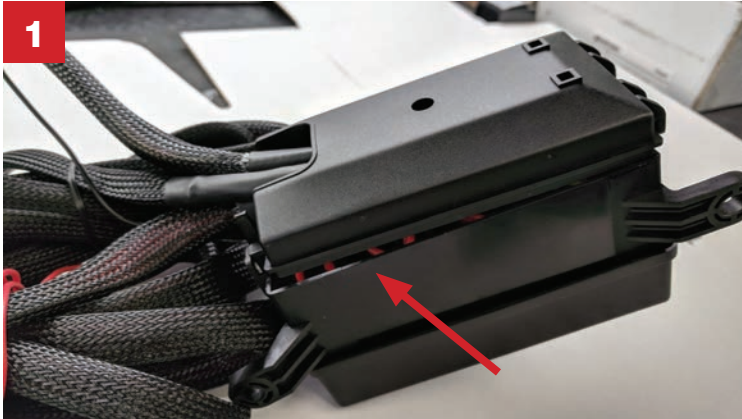
1 Showing the unwanted gap.

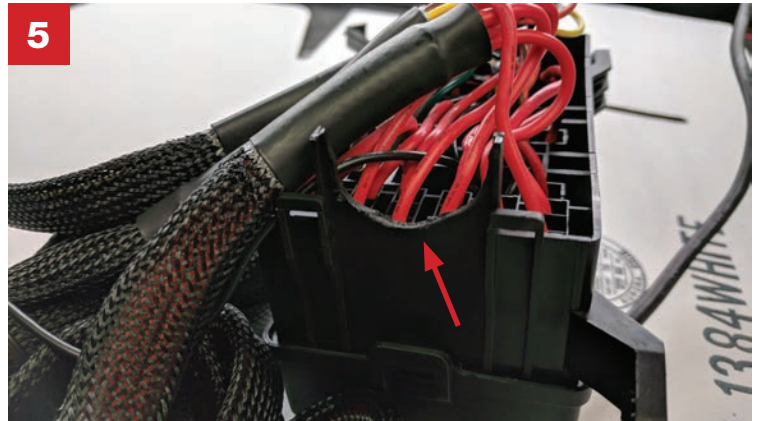
5 Showing the exit tunnel made deeper.

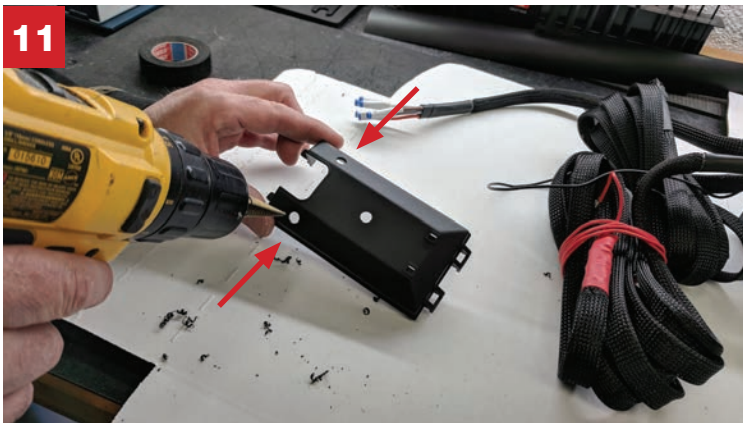
11 Showing the location of the holes to be drilled.

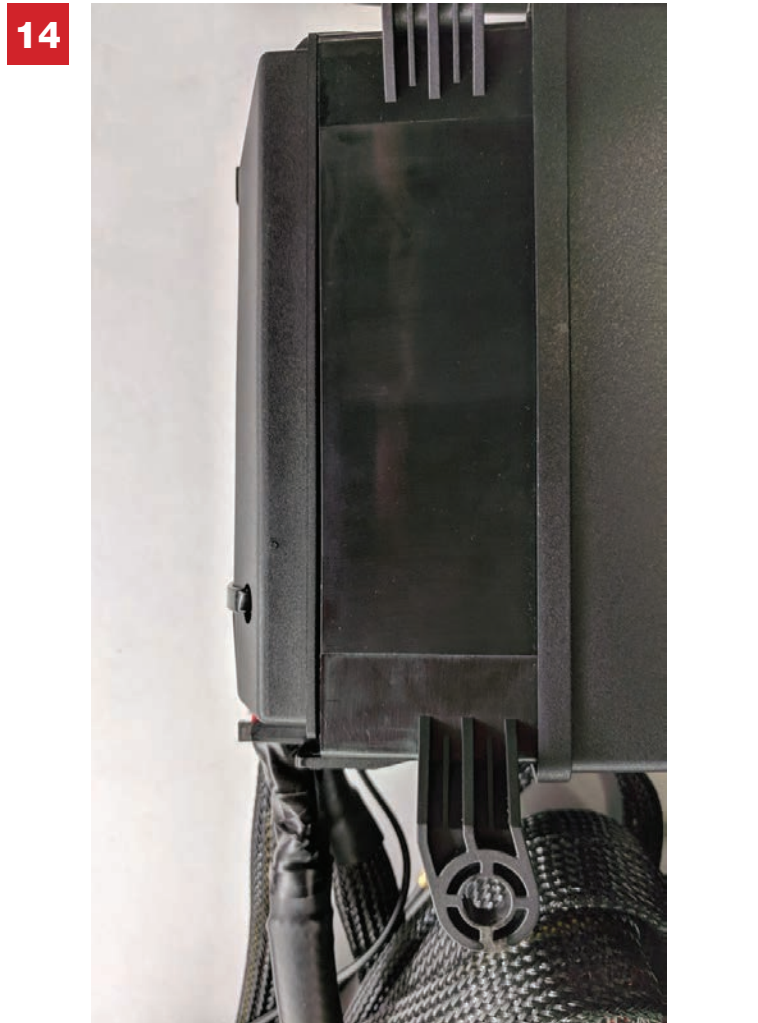
14 Gap is now deleted.
